## Flexible Braided Stainless Steel Hose Failures

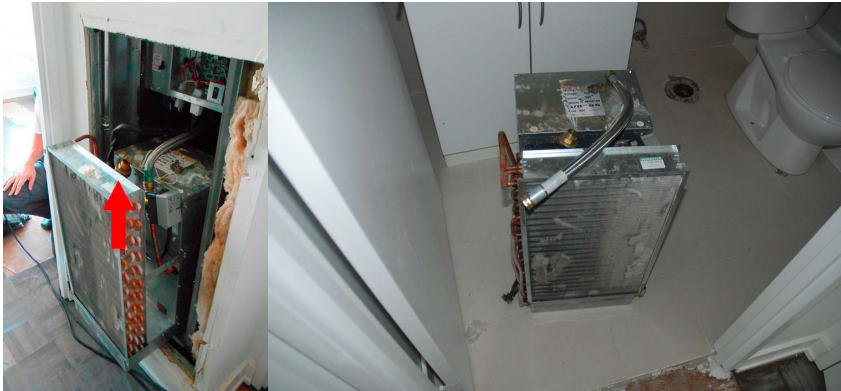
Water source heat pumps are equipped with flexible braided stainless steel hoses – that is, flexible rubber hoses covered by a braided, stainless steel exterior to provide additional strength. Often, both ends of these hoses are equipped with fittings, commonly seen on garden hoses, that connect the heat pump to a building's water supply system. For reference, examples of a braided stainless steel hose and a water source heat pump are pictured below.

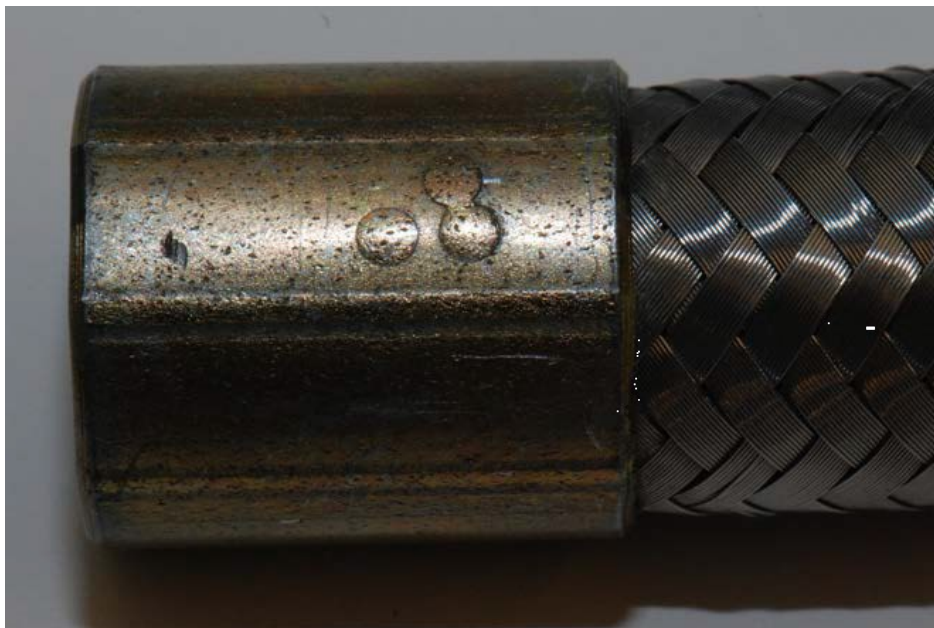
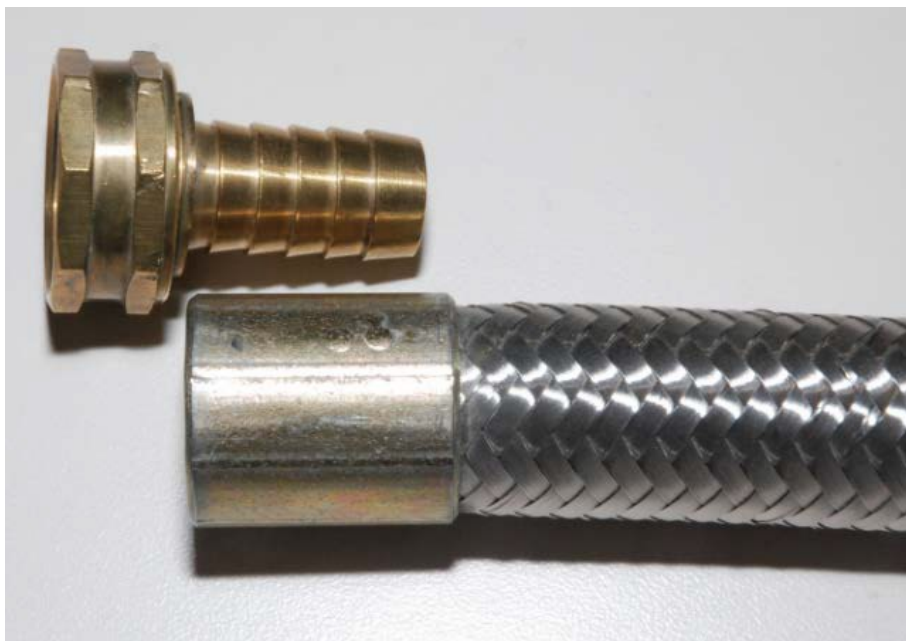
Cozen O'Connor is handling several matters in litigation in Canada involving the failure of braided stainless steel hoses on water source heat pumps. The hoses allegedly have been improperly manufactured. The failure mode at issue in the litigation is that the garden hose-style fitting slips out of the hose, an example is pictured below. The fittings are secured in place with steel sleeves – known as ferrules – that are crimped around the hose fittings to hold them in place. Through our research and investigation with engineers specializing in material failures, a batch of 500 braided stainless steel water hoses manufactured in or around July/August of 2011 may have been improperly crimped or otherwise improperly manufactured and tested, causing the fittings to slip out of the ferrule.

- Three circular bumps arranged in a triangle fashion on the metal sleeve intended to hold the coupling in place (example below); and
- A label indicating that the hose was pressure-tested in or around July-August of 2011.
